U. S. COAST GUARD CAPTAIN OF THE PORT  
MARINE SAFETY INFORMATION BULLETIN 008-22

**Oregon Inlet, North Carolina**  
**Severe Shoaling and Re-Positioning of Aids To Navigation**

May 20, 2022

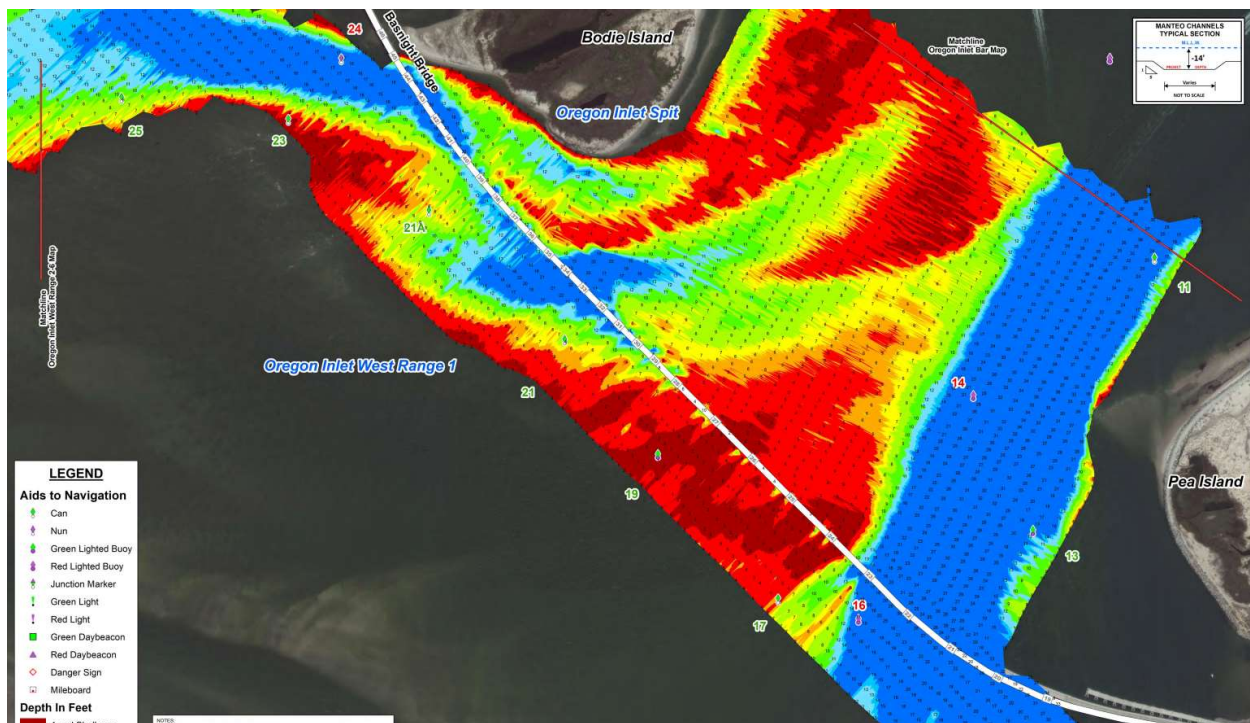
Significant shoaling exists between Oregon Inlet Buoy 17 (LLNR 28055) and Oregon Inlet Channel Buoy 21 (LLNR 28070), reducing channel depths to two to three feet at mean low water as indicated by the U.S. Army Corps of Engineer's hydrographic survey performed on May 18<sup>th</sup>, 2022. The shallow depths of the current channel will not permit use of the U.S. Army Corps of Engineer Shallow Draft Fleet dredges to clear the channel. Under the current condition, these aids to navigation can no longer be configured or maintained to safely mark a passable channel. As such, Oregon Inlet Buoy 17 (LLNR 28055) will be temporarily disestablished and Oregon Inlet Channel Buoy 21A (LLNR 28073) will be discontinued. Oregon Inlet Lighted Buoy 19 (LLNR 28065) and Oregon Inlet Channel Buoy 21 (LLNR 28070) will be re-positioned to the northeast to mark good water.

The Coast Guard is not closing or otherwise restricting the waterway. Boaters choosing to transit through this channel do so at their own risk and should use extreme caution. The Coast Guard and U.S. Army Corps of Engineers are currently coordinating and actively investigating other potential areas where a marked channel can be established to provide access to and from Oregon Inlet.
